May 25, 2017  
Job #17-547

Re: Structural Observation of Hilltop House in the Town of Apple Valley

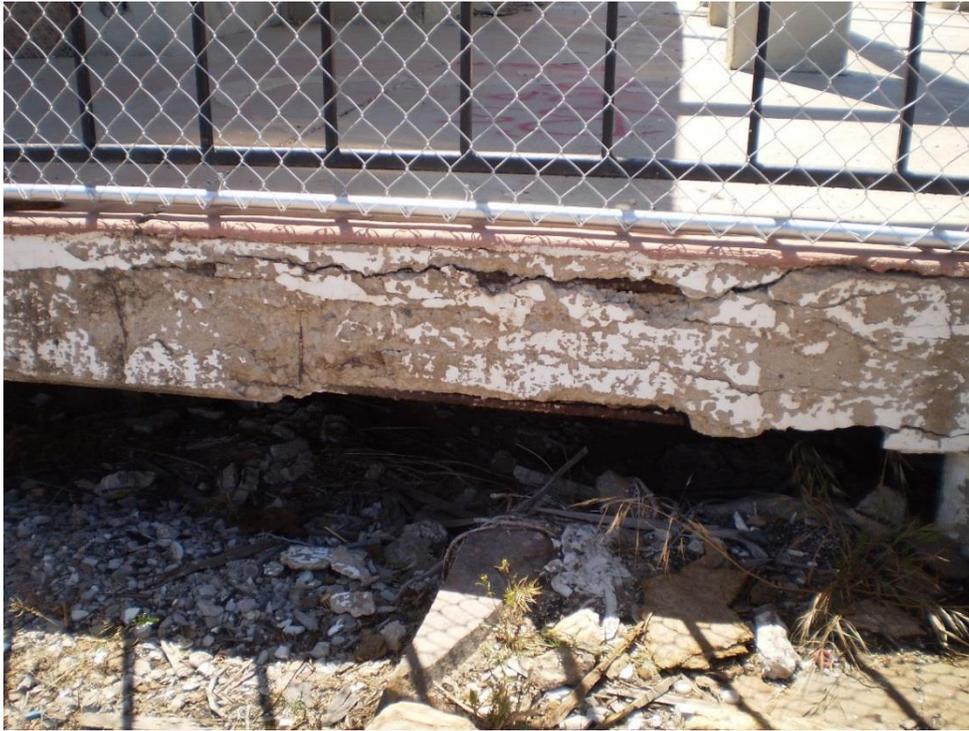
The stucco at the wood walls and exterior columns has extensive damage. There is fire damage and partial collapse of a portion of the wood floor joists above the “tuck-under” parking. Elsewhere the wood floor joists appear to have water damage. The exterior concrete deck has large amounts of cracked and spalling concrete as well as several locations with exposed steel reinforcing. The cantilevered portions of the wood deck has holes, soft spots, and is structurally unstable. The pool and surrounding deck is failing. The pool has large cracks and spalling concrete. The concrete columns supporting the concrete deck have significant amounts of cracked and spalling concrete. Similarly the concrete beams at the concrete deck and the concrete stairs also have large amounts of concrete spalling, cracking, and exposed steel reinforcing. The steel members that were visible appear to be in a good state of repair, but this would need to be re-evaluated once demolition of surrounding unsafe members and elements was performed due to limited access to large portions of the members. The guard rails do not meet current code and would need to be replaced.

Excessive concrete spalling, cracking, and exposed reinforcing bars at concrete deck

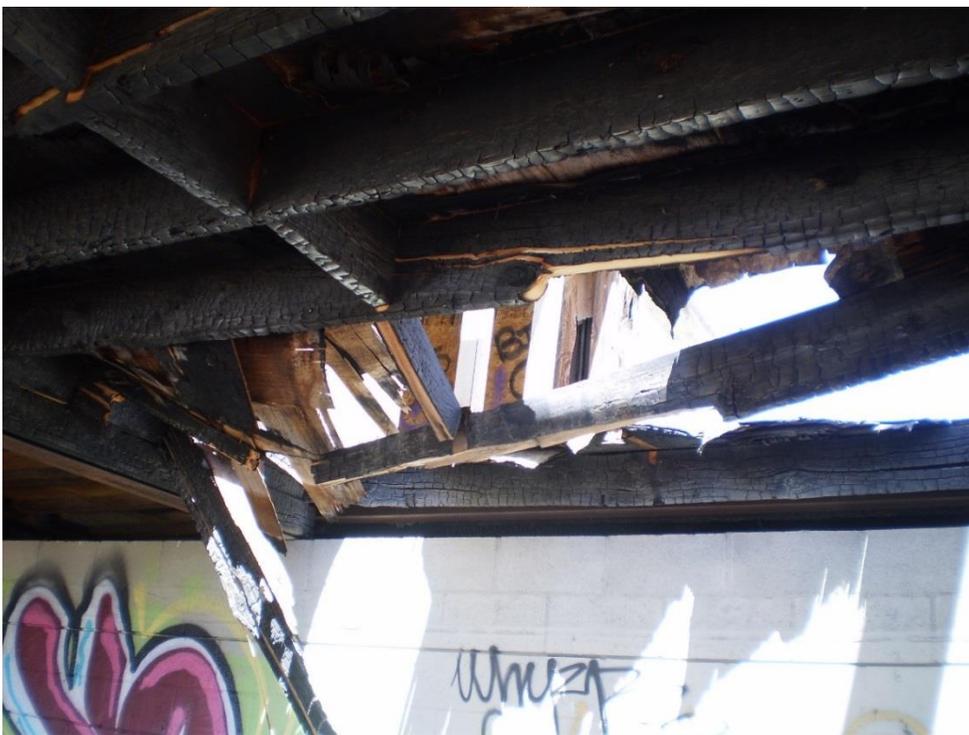
Fire damage at wood floor

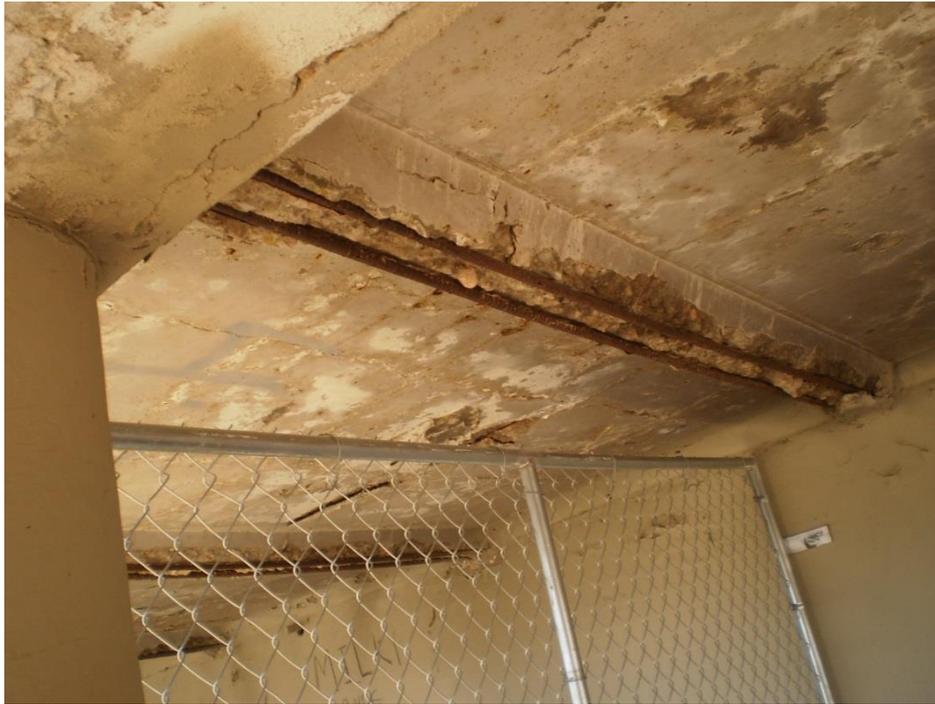
Excessive concrete spalling, cracking, and exposed reinforcing bars at concrete beams

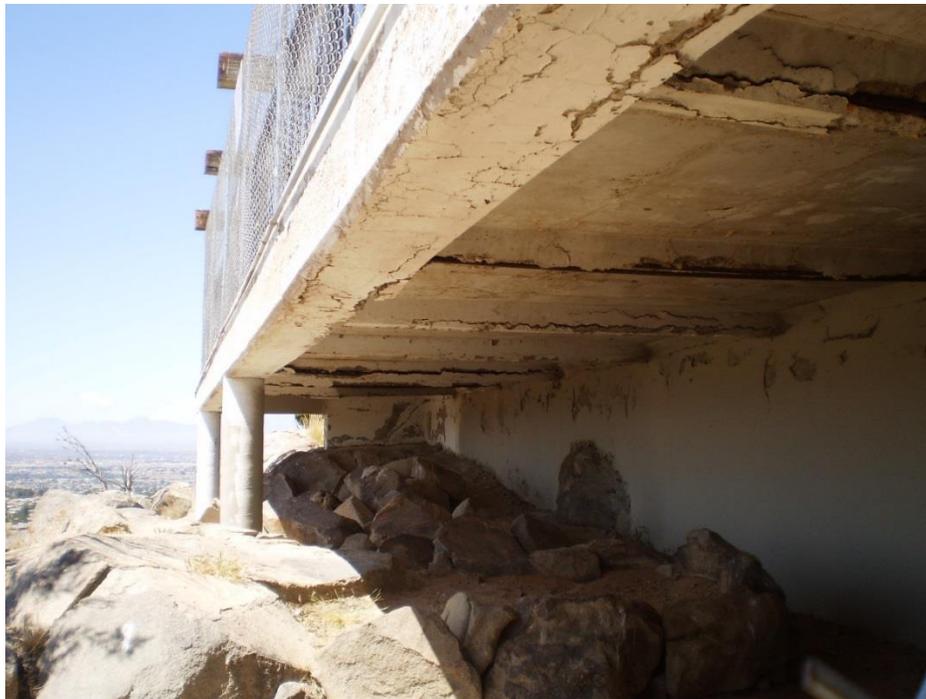
Excessive concrete spalling, cracking, and exposed reinforcing bars at concrete deck

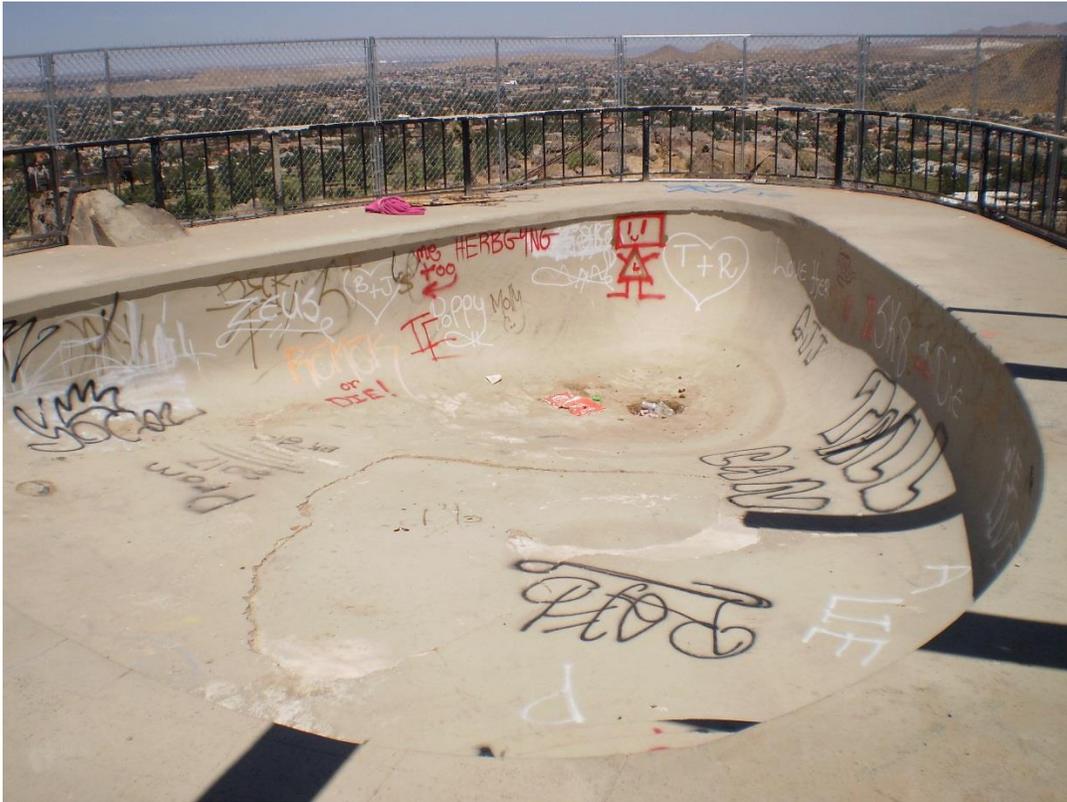
Damage to pool shell and surrounding deck
